Revision: 2	<i>Keith Snook .info</i>	Page Size: A4	<i>iss. 2 R10 value and R16 position</i>
<b>QUAD II Concordant modified ?</b>			
8 Feb 2005	Drawn: K. Snook	Checked:	Page 1 of 1

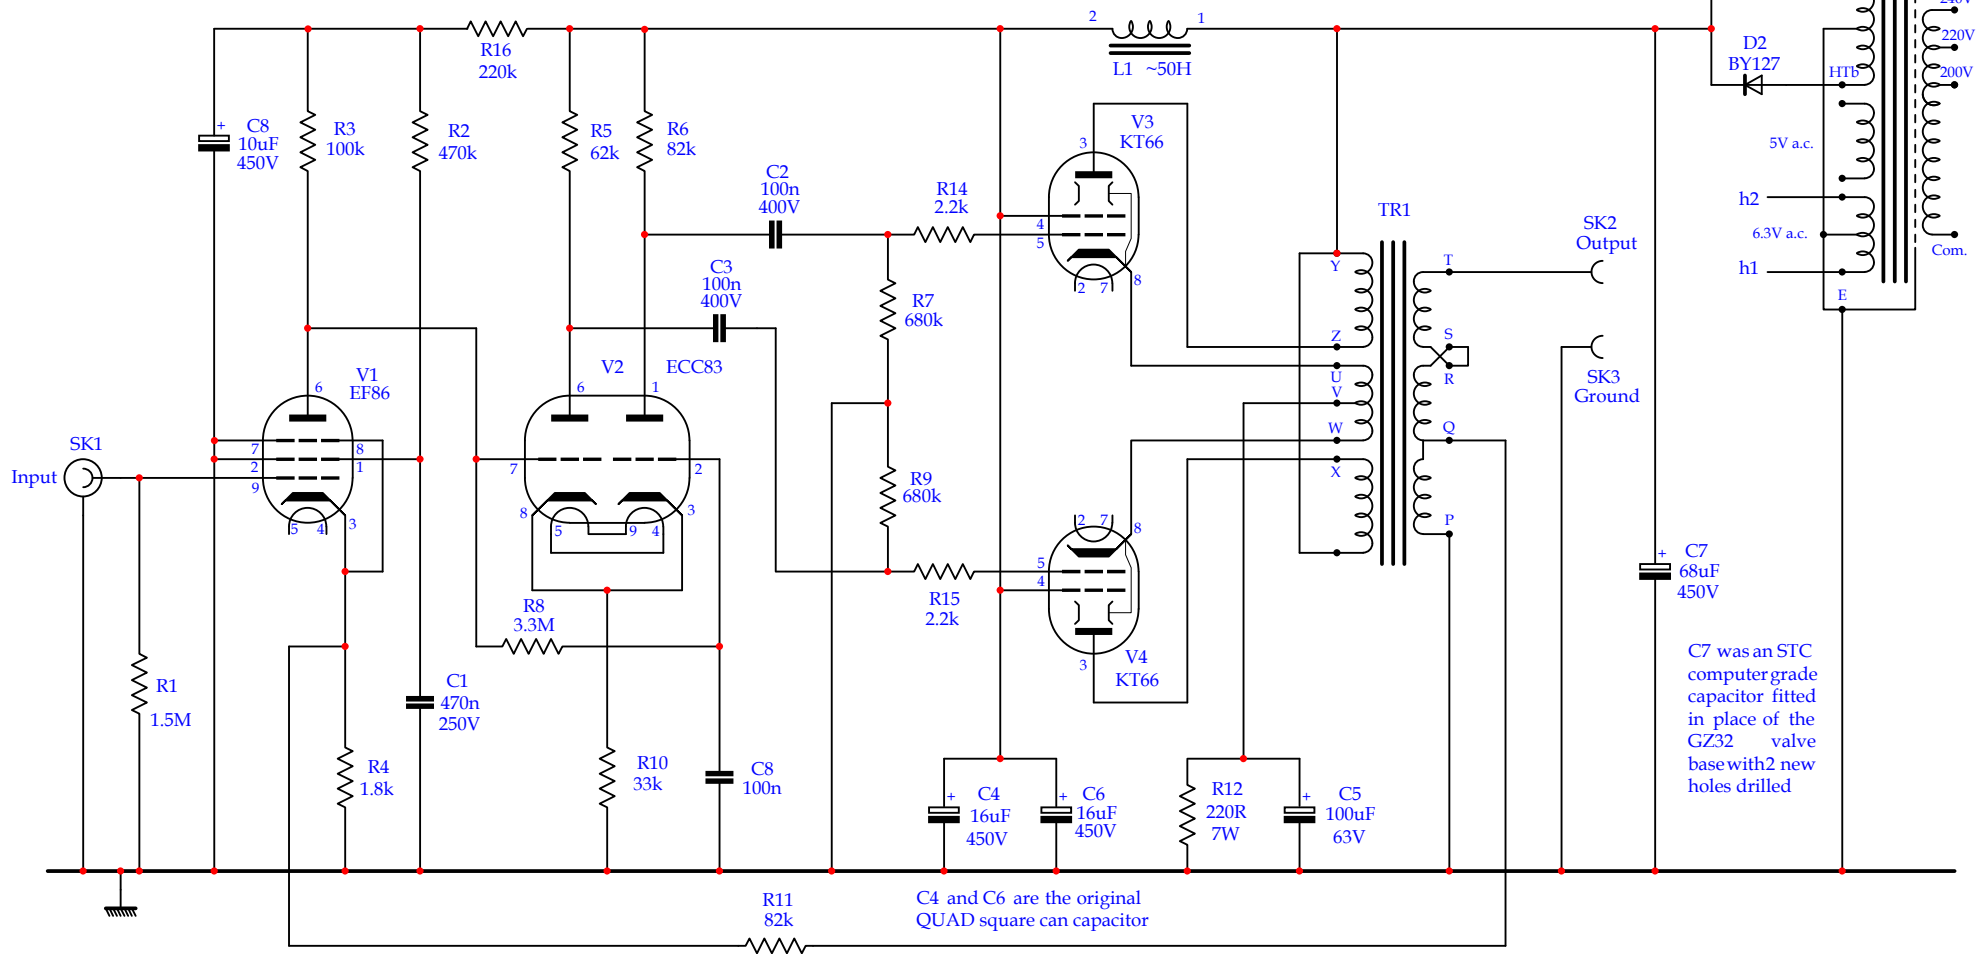
Note: R5 and R6 values are marked as found but are wrong - Both should be the same value ? This appears to be copied - incorrectly - from the LEAK or BBC type phase splitter which is not directly coupled from the previous stage

Note; V3 and V4 are shown as KT66 but valves fitted were the underated 6Y6

C7 was an STC computer grade capacitor fitted in place of the GZ32 valve base with 2 new holes drilled

C4 and C6 are the original QUAD square can capacitor
